Rainfall Analysis and Discharge Estimation for the July 27, 2014 Flow Event on Sonoita Creek

HUDBAY

Rosemont Copper Project

Water & Earth
TECHNOLOGIES

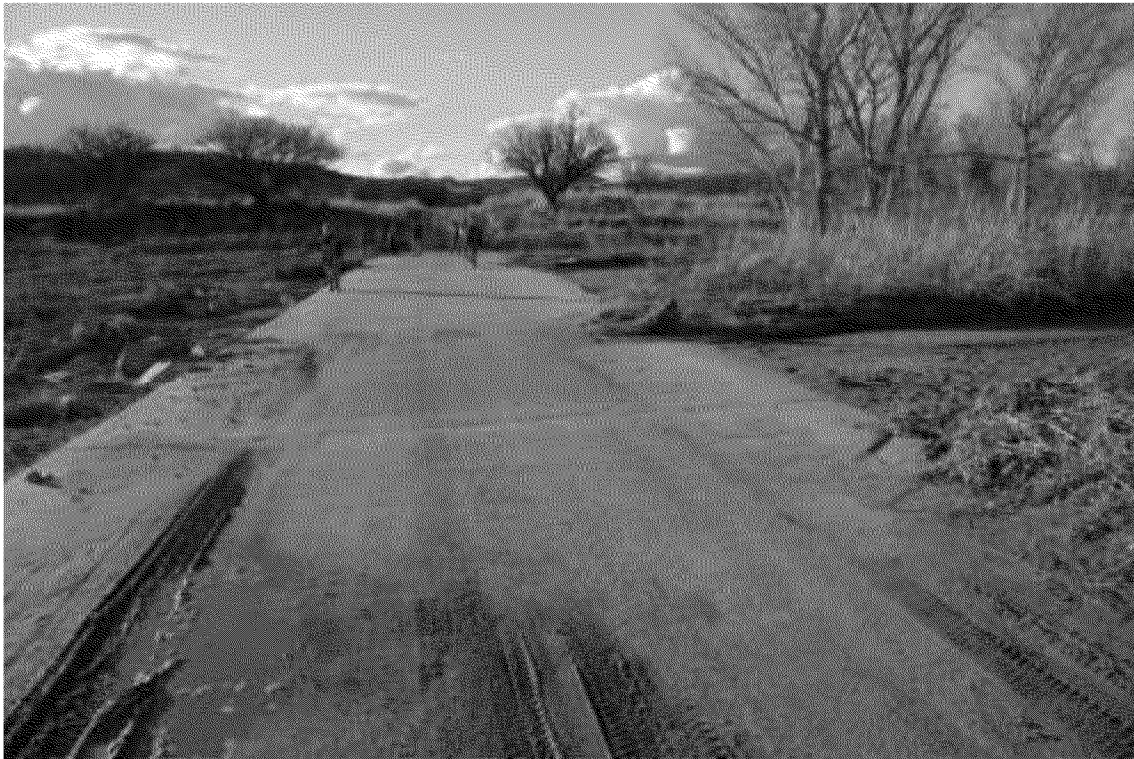
Figure 3. Road Crossing (First of Two Photos; Downstream to the Left)

Figure 3 and Figure 4 are photos from the site visit that show the road crossing. The width of the concrete crossing estimated from the photos is approximately 15 feet. On the downstream side of the crossing there is an immediate drop off of approximately 1 foot to the earthen channel. High water marks were identified in the field and can be clearly seen in the photo (Figure 4). Maximum water depth was approximately 2 feet on the left side (looking downstream) of the cross section, where the concrete road crossing is lowest. The right side of the stream cross section at the concrete crossing is slightly higher and high water marks there were shallower at just over 1 foot.

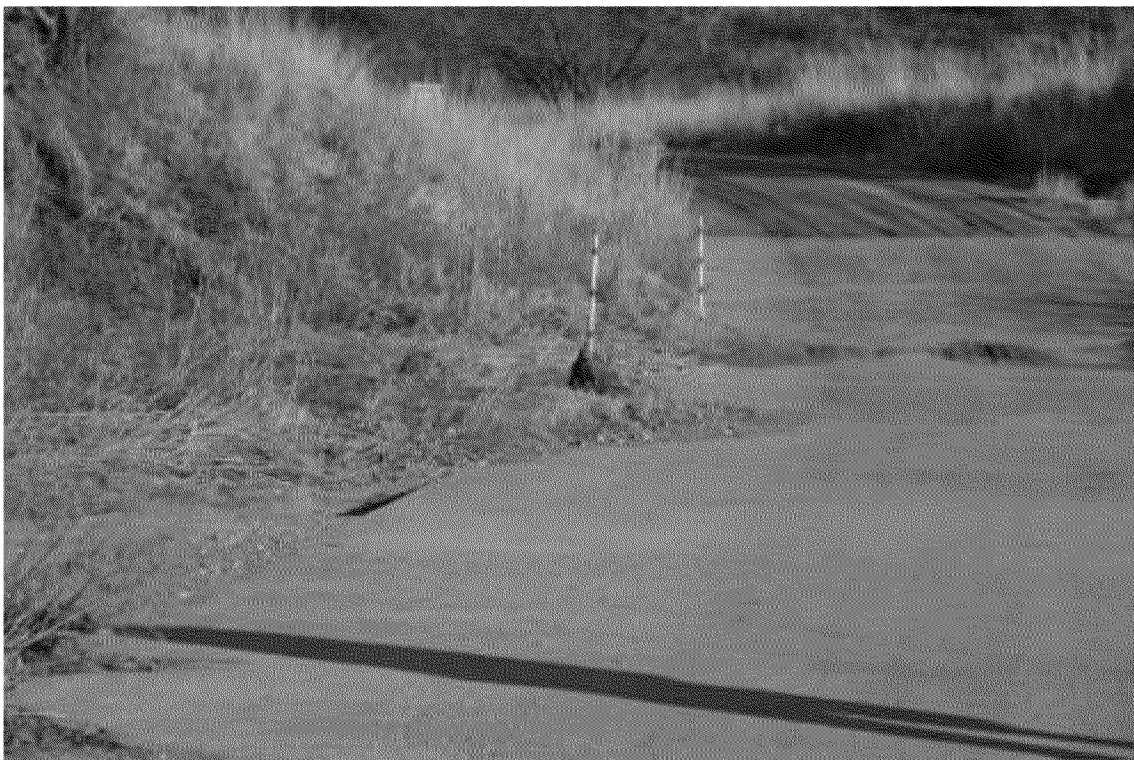
**Figure 4. Road Crossing (Second of Two Photos; Downstream to the Right)
with Visible High Water Marks and Debris Accumulations**
